# Technical Performance: Ecoremedy® Gasifier Poultry Litter Furnace

A summary of preliminary technical performance findings funded by the  
Farm Manure-to-Energy Initiative

January 2016

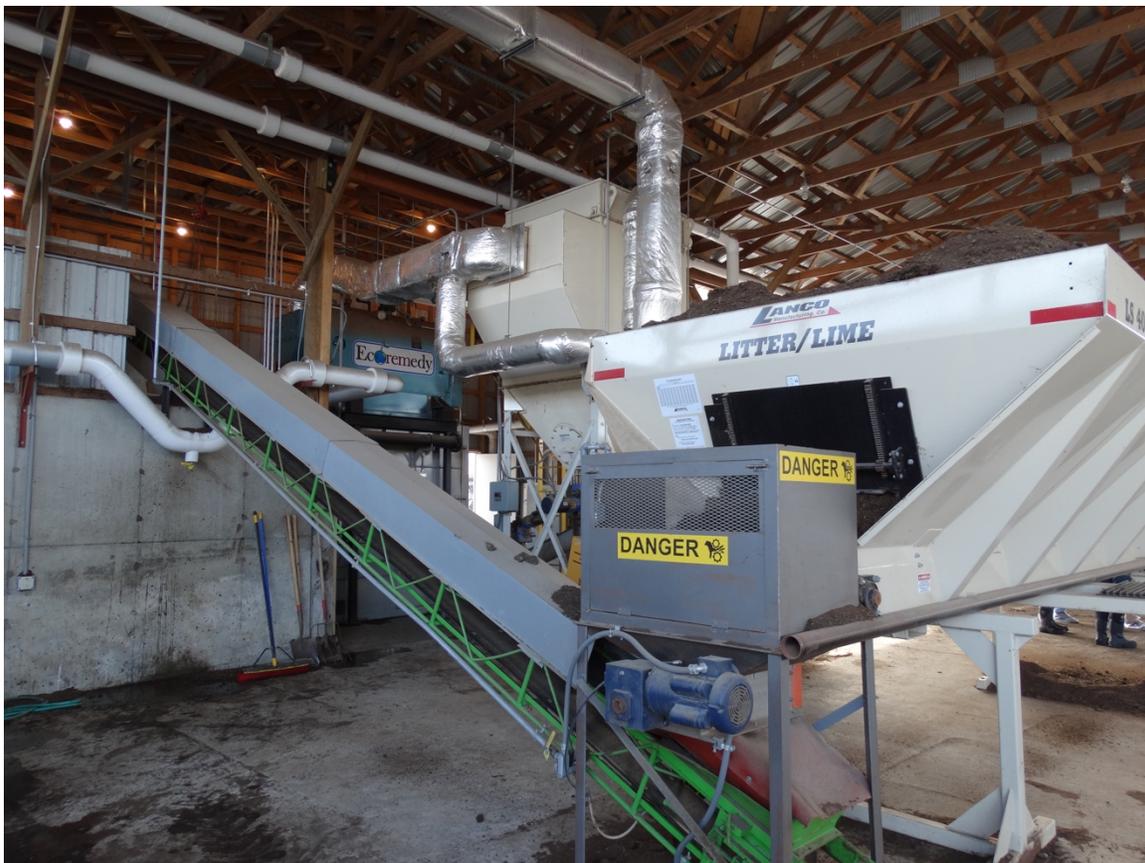
**Figure 1.** Litter starts in the litter spreader (white piece of machinery) that goes through a lump breaker (grey piece labeled “Danger”) and then is conveyed to a hopper above the gasifier (hopper not pictured).

The Eco remedy system consists of four primary components: 1) the gasifier; 2) the boiler; 3) the material handling system for fuel and ash; and 4) the hydronic heating system. The litter is loaded into a standard litter spreader modified with an electric motor to move the litter into the gasifier (figure 1). Prior to entering the gasifier (figures 2 and 3), the litter passes through a de-lumper, which breaks up the clumps in the litter (figure 1). After the de-lumper, the litter moves via a conveyor belt to a surge hopper on the gasifier, which also acts as an airlock.

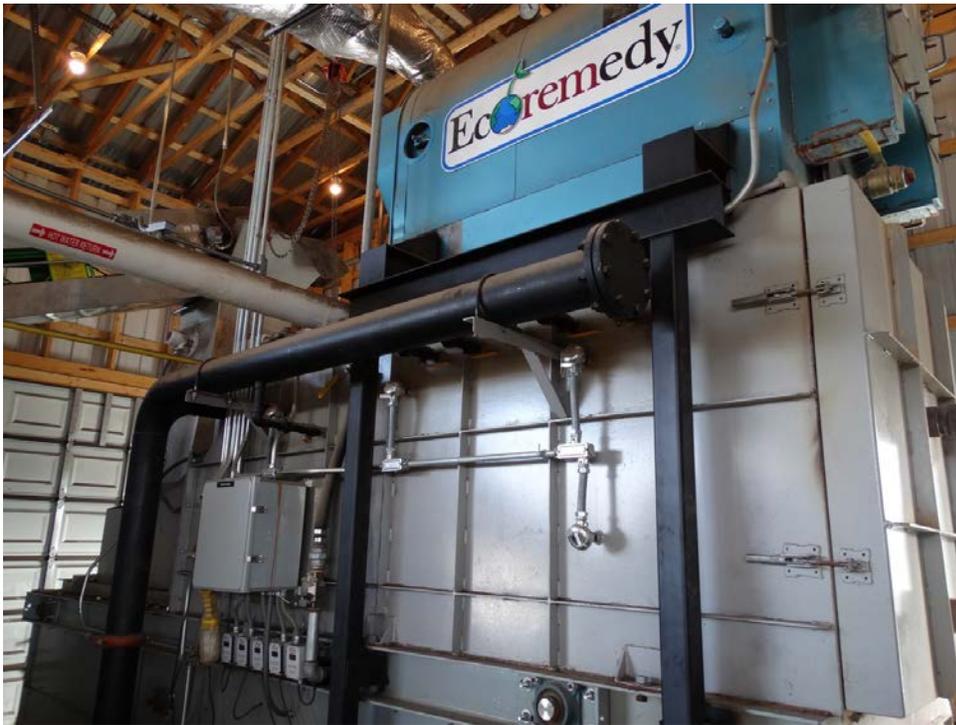
**Figure 2.** The gasifier is the gray colored device and the boiler is the blue colored equipment at the top. The litter flows through the unit from left to right.

From the secondary combustion chamber, hot gases flow into a three-pass fire tube boiler (figure 2). This boiler is a standard off-the-shelf boiler (Superior Boil Works, Inc. Model #MS3-OB-270-W30) with the entrance modified to bolt to the gasifier. The flue gases leave the boiler and are pulled through the system by an exhaust fan. There are two cyclones in series that are designed to control particulate matter emissions. After the flue gases leave the cyclone they are vented to the atmosphere.

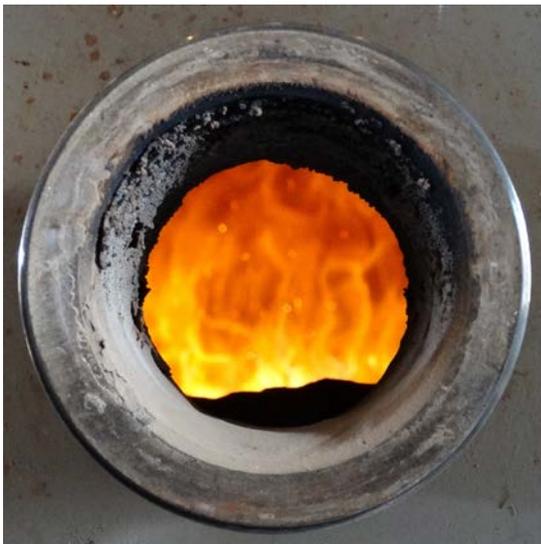
**Figure 3.** Flame from the combustion of the gasifier-generated syngas inside the combustion chamber.

The syngas created in the gasification zone flows into a separate chamber above the gasification chamber where secondary combustion air is blown in at different locations to completely oxidize the fuel. This two-stage system allows for complete control of the combustion process and complete oxidation of the fuel.
